# TechTips For HAPPY HCA/HCG machines

## Easy Repairs on Normal Wear & Tear Upper Faceplate adjustment

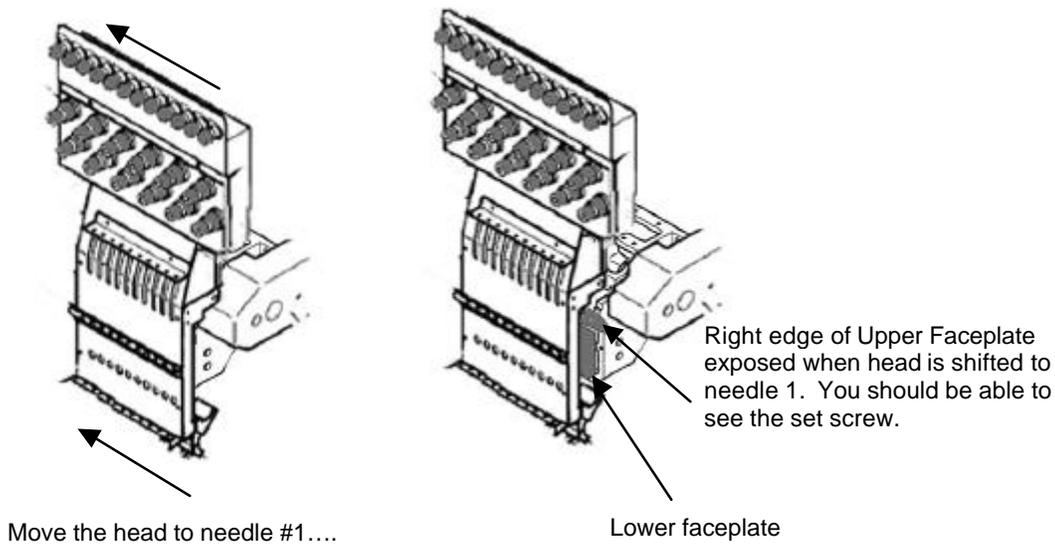
1. If this is happening on a multi-head machine, remove the access panels on either side of the head that is exhibiting the problem.
2. With the machine powered on, use the control panel to select needle 1. This should expose the right edge of two black, rectangular plates. The upper, narrow one is called the Upper Face Plate. Look for a single screw (depending on which model machine you have, this may be a flat-tip or Phillips-type screw).

3. Loosen this screw with your screwdriver SLIGHTLY – leaving enough tension to keep the plate in place, and tap the upper faceplate downwards approx. 1-2 mm.

4. Re-tighten the screw. Test your machine. The problem may be solved at this point. If not, continue to step #5.
5. Use the control panel to select the opposite end needle – 8, 10, 12 or 15. This should expose the left edge of the Upper Face Plate.

6. Repeat steps (3) and (4) for the left edge.
7. Test your machine. The problem should be solved!
8. Eventually, this plate/cushion will not be able to adjust down and the cushion will need replacement. In most cases, the part number is M0408412 “cushion” (except in noise reduction machines)
